# econox

## Measuring & control systems Carbon & Oxygen

**This presentation covers practical experiences of O<sub>2</sub> probe failures or deviations in heat treatment (%C) and the implemented corrective actions**

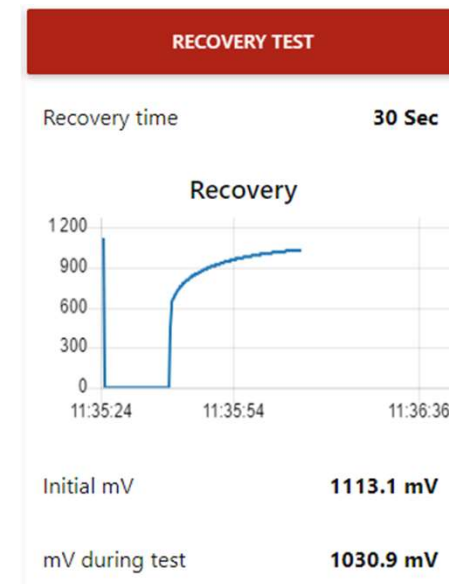
- After a few days, the probe's mV reacts very slowly to additional gas injection
- On our test furnace, we observed the following phenomenon after the recovery test :
  - 30 seconds after the short-circuit is lifted, a value of 1030 mV is reached, compared with an initial value of 1113 mV.
  - The probe is out of order

- After investigation, the customer informed us that he used **boron-based carburising stop-off paints**.
- Boric acid vapors formation results in **attacking** both the chromium oxide layer of the refractory material (vitrification) and the zirconia.

Remove Boron protective stop-off paints and replace it with another one

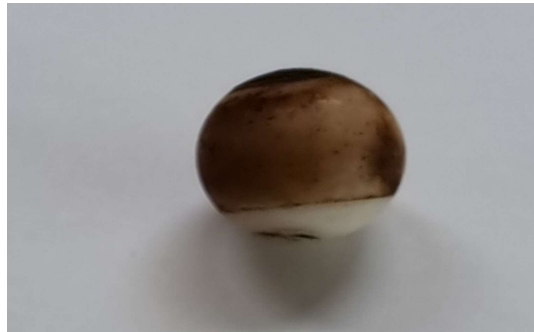
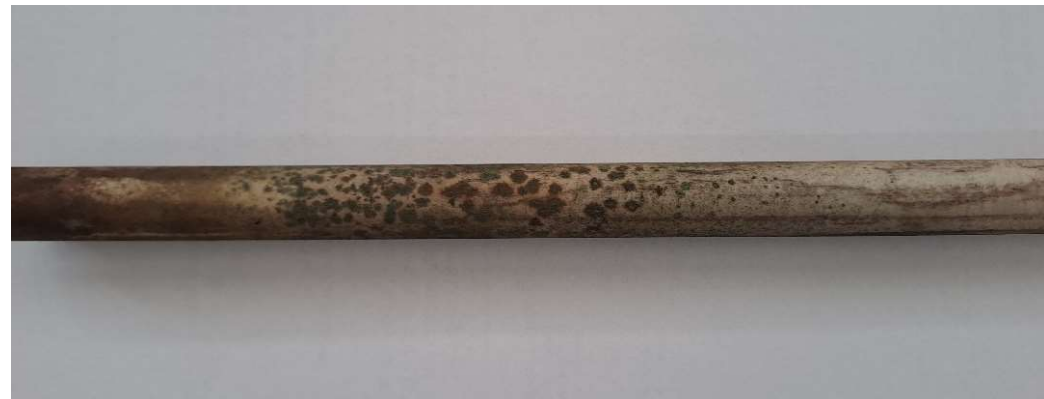
Example of a ball (doped  $\text{ZrO}_2$ ) and a seat tube ( $\text{Al}_2\text{O}_3$ ) that have been subjected to chemical attack.

These are not carbon deposits, as the 2 parts were exposed to air at a temperature of  $1000^\circ\text{C}$  for 4 hours.

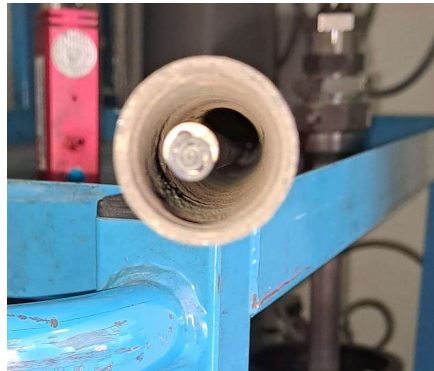
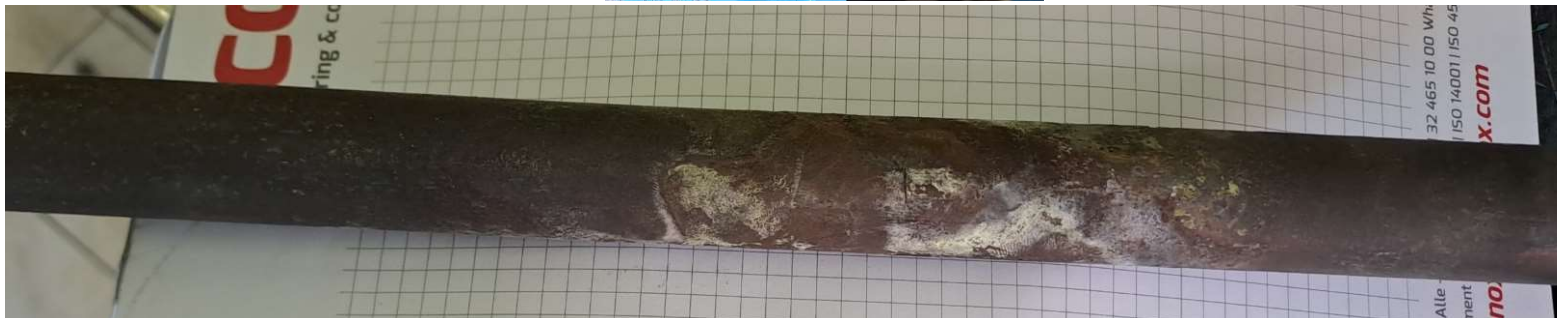
- We received a probe back with the pellet at the end of the outer tube disintegrated.
- On the outer tube we can see white deposits.

- The customer is using alkaline detergents.

- Neutral detergents without salts should be used
- Carefully wash the parts and the loading material before heat-treatment

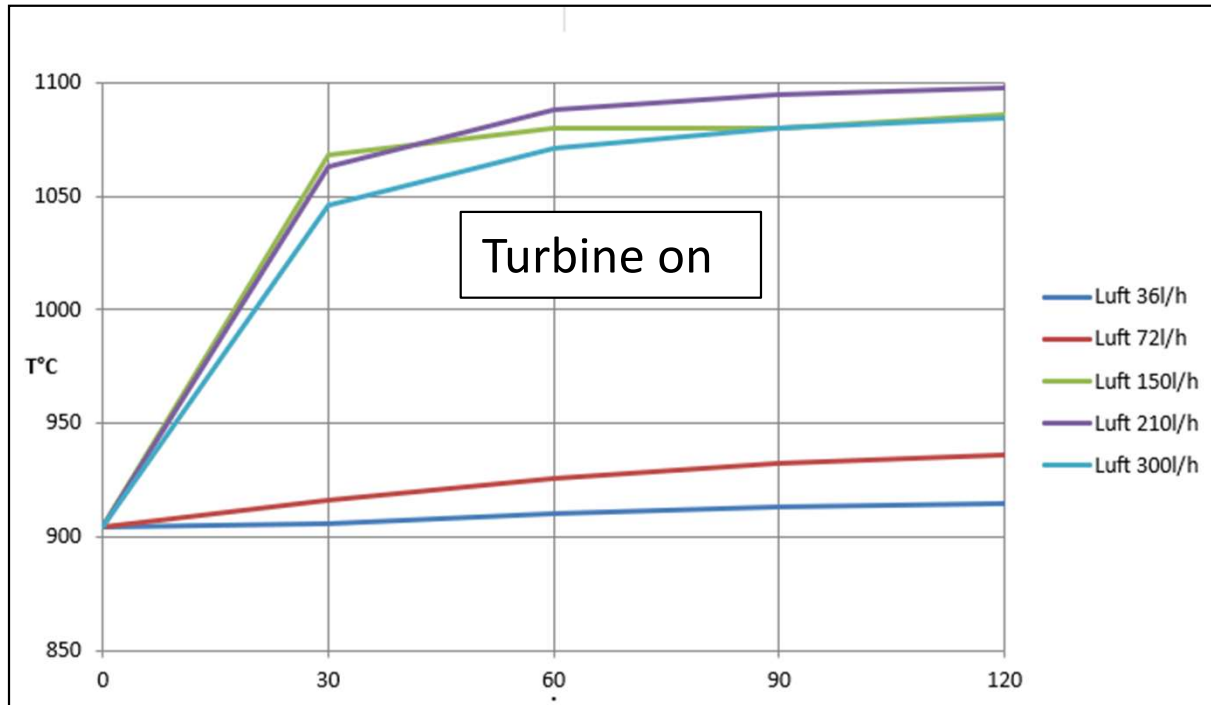
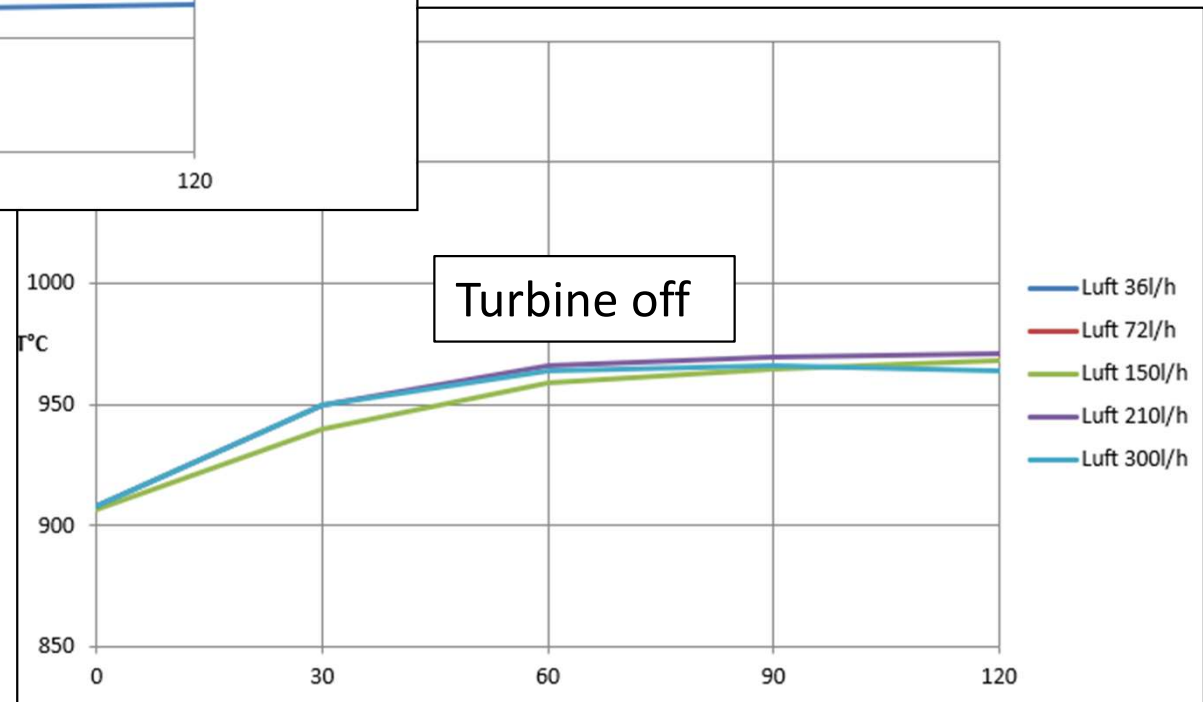
## T°C increasing on probe tip vs turbine on /off

- A reduction in the exothermic effect of the reaction between the furnace atmosphere and the burnoff air
- An increase in the free oxygen value at the probe sensor, resulting in more efficient combustion of carbon deposits.
- In addition, by reducing the air flow rate, the carbon potential of the atmosphere is less disturbed.

- To avoid the often-random adjustment of purge air flow rates, the furnace turbine should be stopped for the duration of the burnoff.

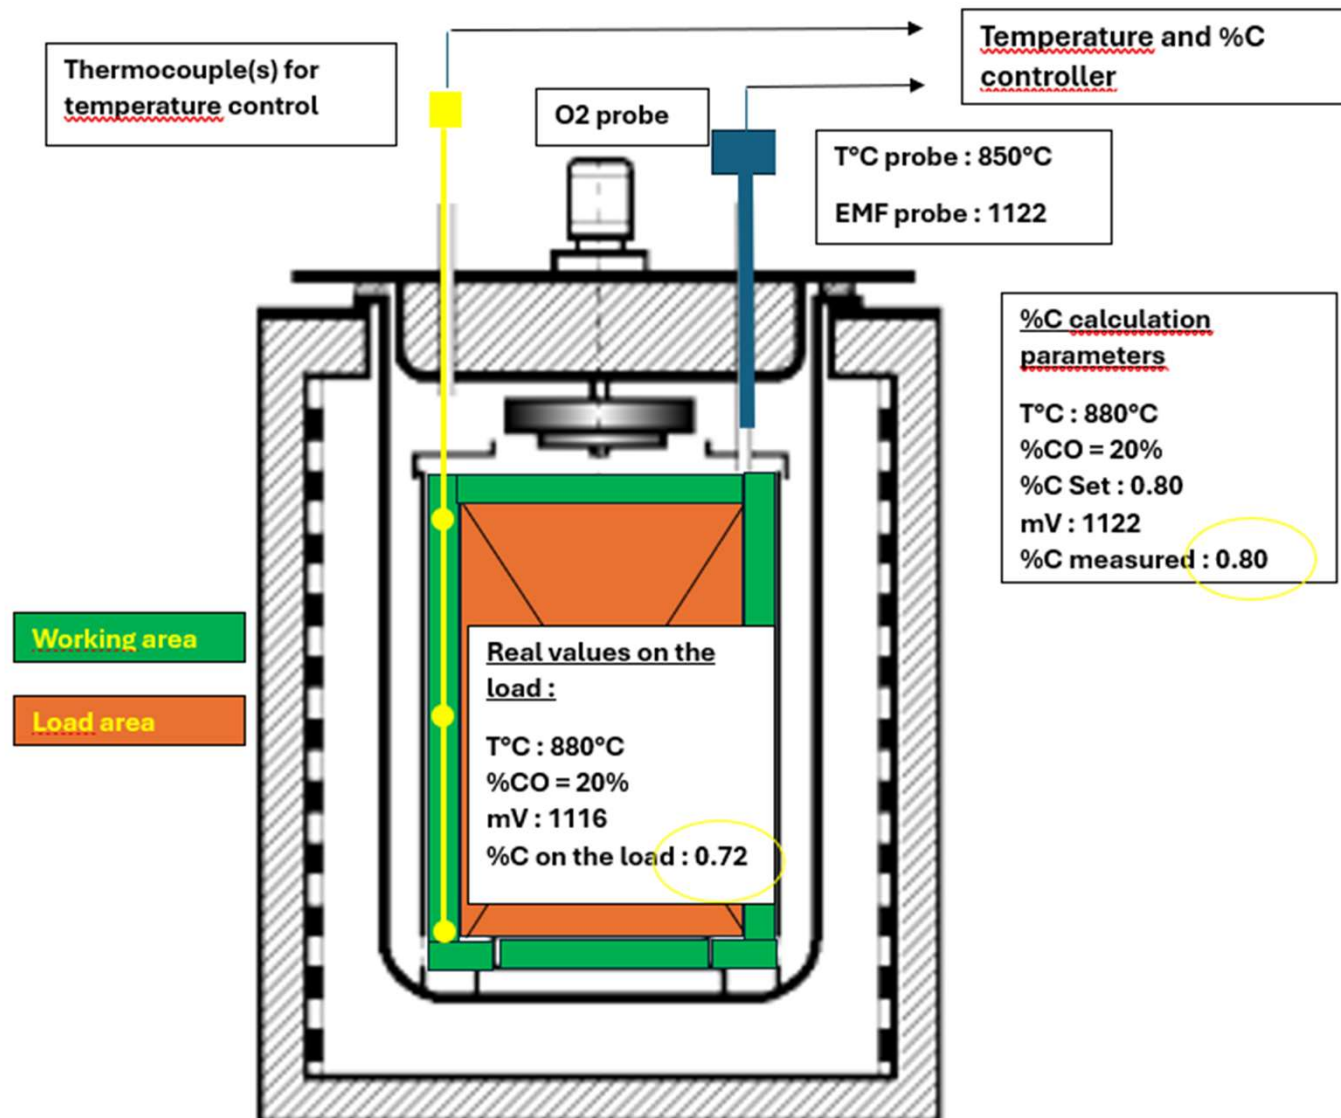
- The probe was not placed in the useful volume of the oven and was not fitted with a thermocouple.
- A difference of -30°C vs load temperature was measured.
- This results in a higher carbon reading than that in the load

Exemple : a difference of 30°C gives a deviation of 0.08%C

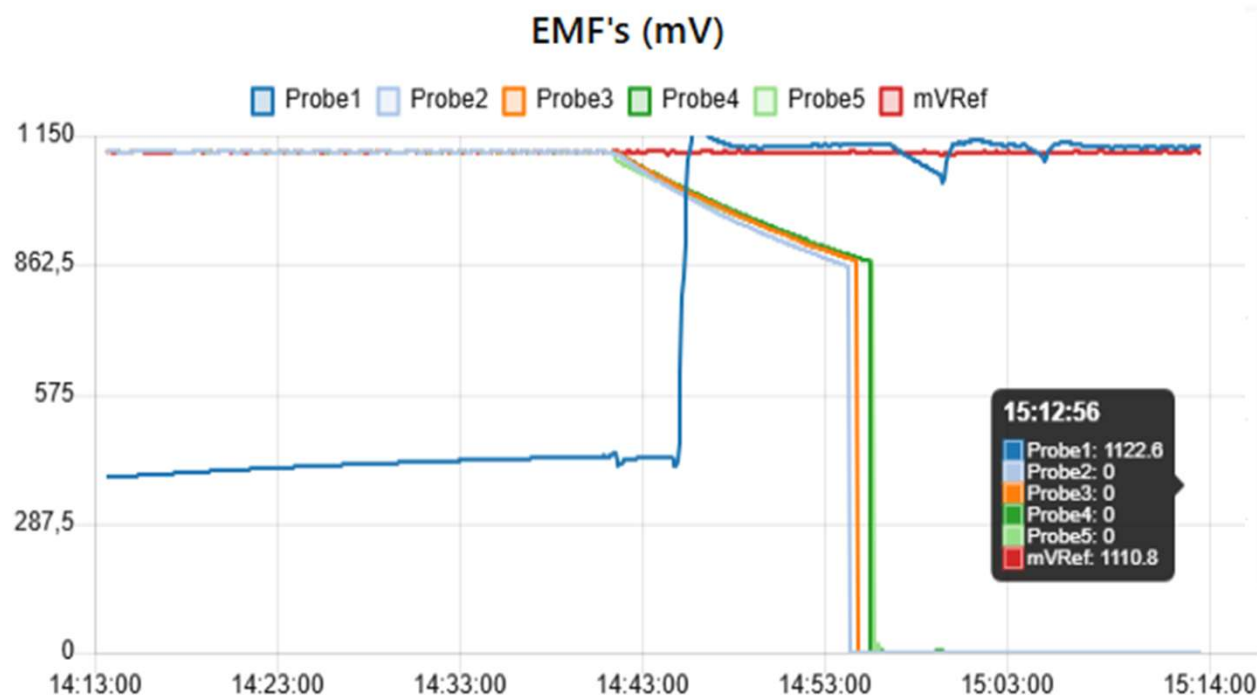
-Over voltage on redundant Probe 5433 vs. reference probe

$$\Delta \text{ mV} = 12\text{mV}$$

- For that case **air burnoff was not effective**
- Remove probe from furnace
- Let it cool down
- Clean it with compressed air **ONCE COLD!**

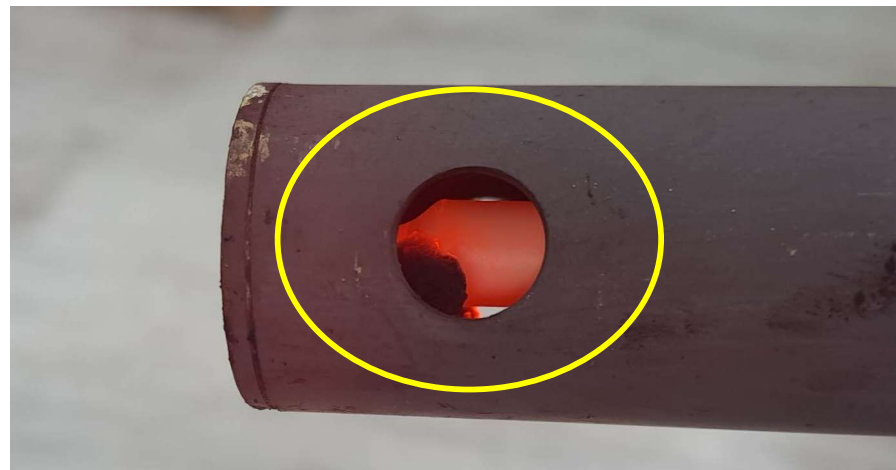
- Carbon deposit on zirconia sensor
- Under certain conditions, **soot can form directly on the zirconia** (adherent soot) or form inside the tube at temperatures of 600-700°C.
- This soot can detach in chip form during thermal cycles and deposit on the zirconia (non-adhesive soot).

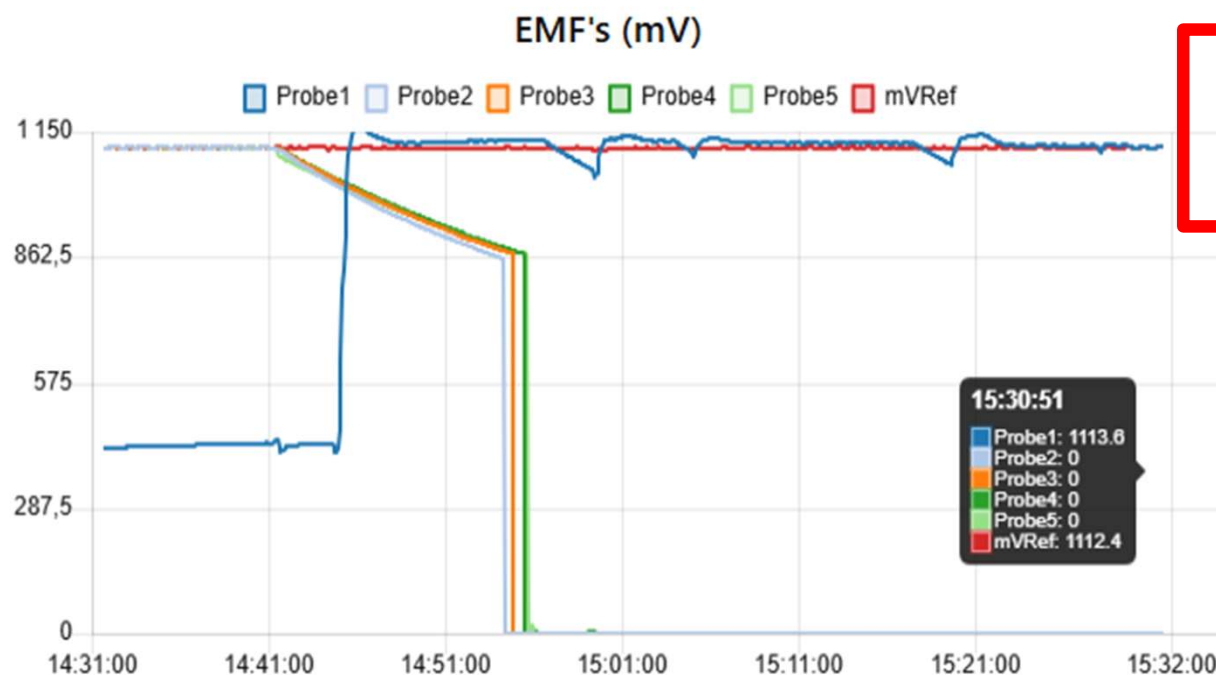
## Results after manual cleaning

$$\Delta \text{ mV} = 1\text{mV}$$

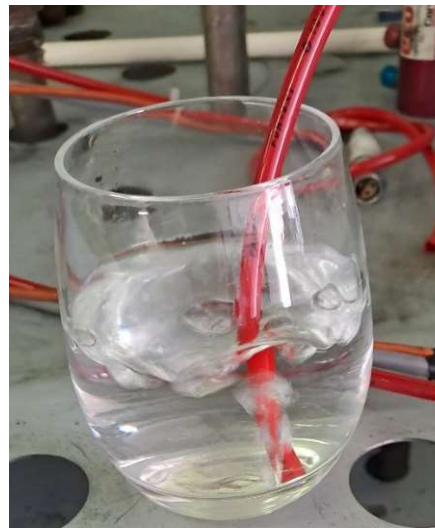
- The purge air solenoid valve was **slightly leaking**, but the leak was not visible on the flowmeter.

**Therefore a little flow of fresh air is entering the furnace,  
lowering the mV read by the  $\text{ZrO}_2$  cell.**

- Replace valve or make sure it is gas-tight by inserting the purge air tube in a glass of water.
- When purge cycle is OFF. **No bubble should be seen**
- The tightness of the purge valve should be periodically checked according section F

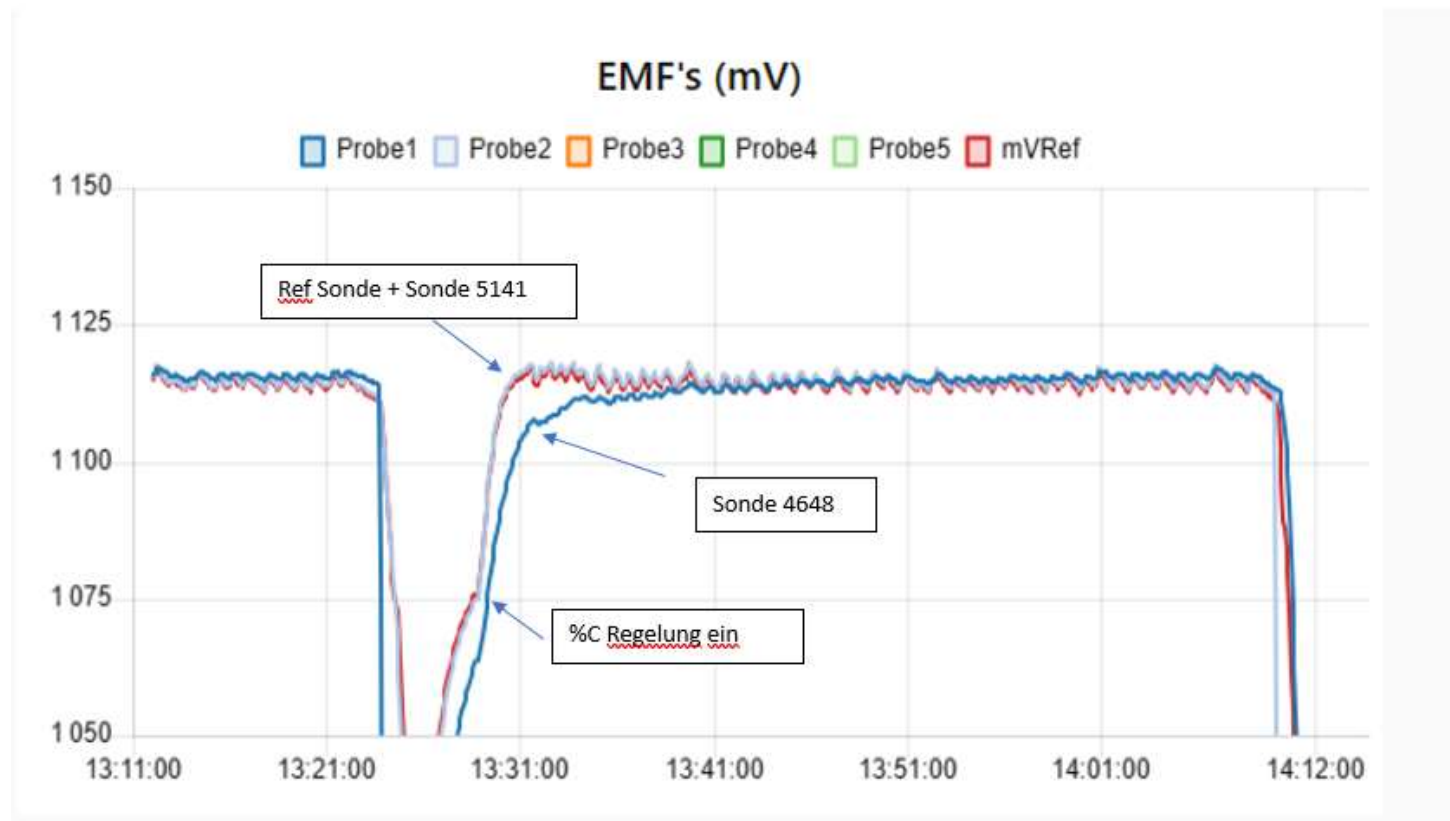
- Alteration of probe reactivity.
- Slow probe response

- When using sodium or potassium nitrite- and nitrate-based quenching salts, the vapors emitted in the furnace during quenching or during heating of **poorly washed charging material** cause **chemical reactions** with zirconia and the refractory metal outer electrode.
- Sodium or potassium vapors **destroy the protective chromium oxide layer**, leading to corrosion of iron and nickel, with the formation of oxide dust deposited on the electrolyte.

- Remove probe for furnace.
- Let it cool down
- Clean it with compressed air **ONCE COLD!**
- Take special care for washing the parts and the fixtures before entering the load in the furnace especially after salt quenching
